**PISCATAQUA RIVER BASIN  
MILTON , NEW HAMPSHIRE**

**MILTON LEATHER BOARD DAM  
N.H. - 00316**

**PHASE I INSPECTION REPORT  
NATIONAL DAM INSPECTION PROGRAM**

**FEBRUARY 1979**

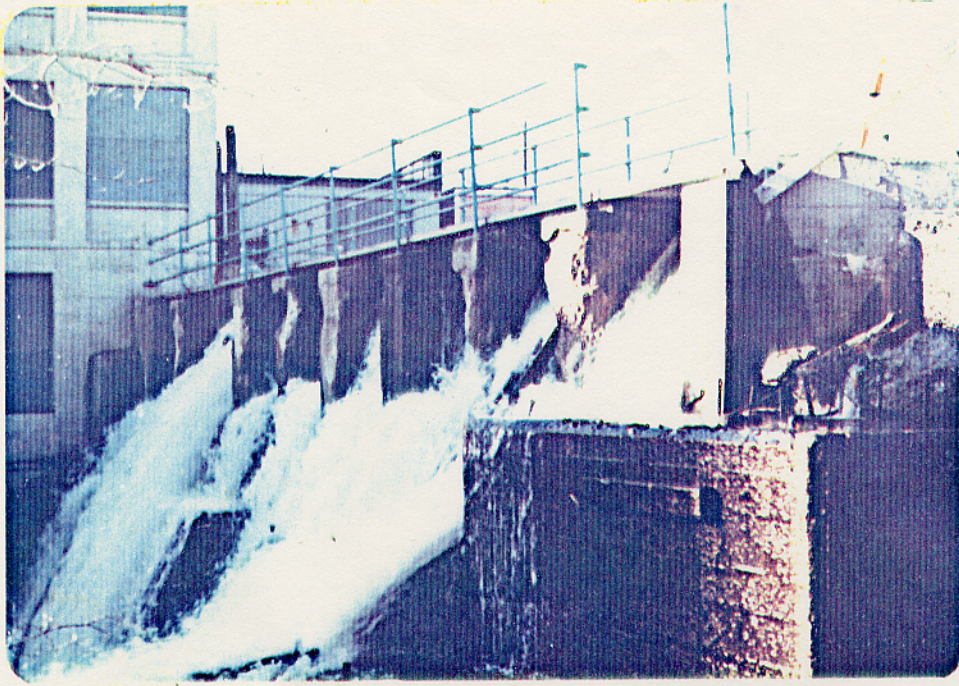
1

STOP LOG SPILLWAY

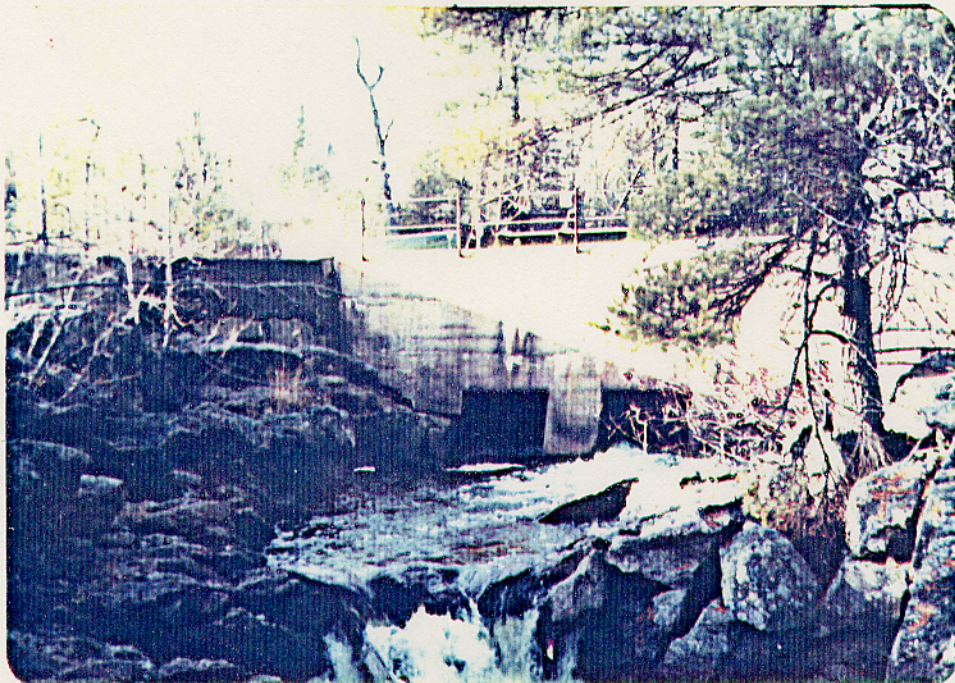
2

- c. Appurtenant Structures. The control outlet of the dam and headworks at the mill were found to be well maintained and in good condition. The gate operating equipment is manual and is in good condition.

OUTLET GATES

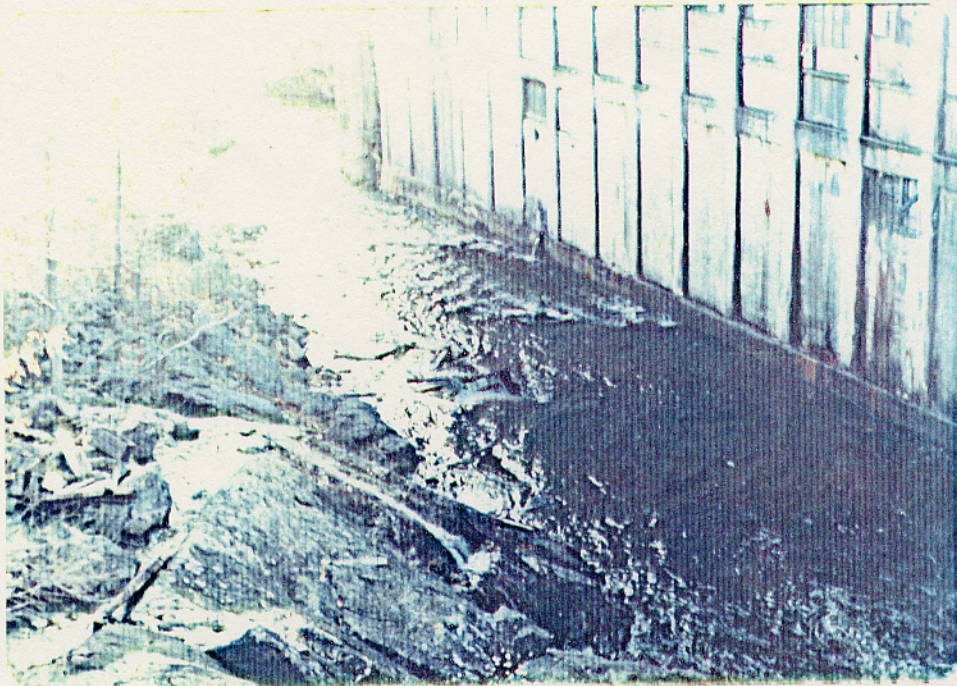
3

CHANNEL-BELOW STOP LOG SPILLWAY

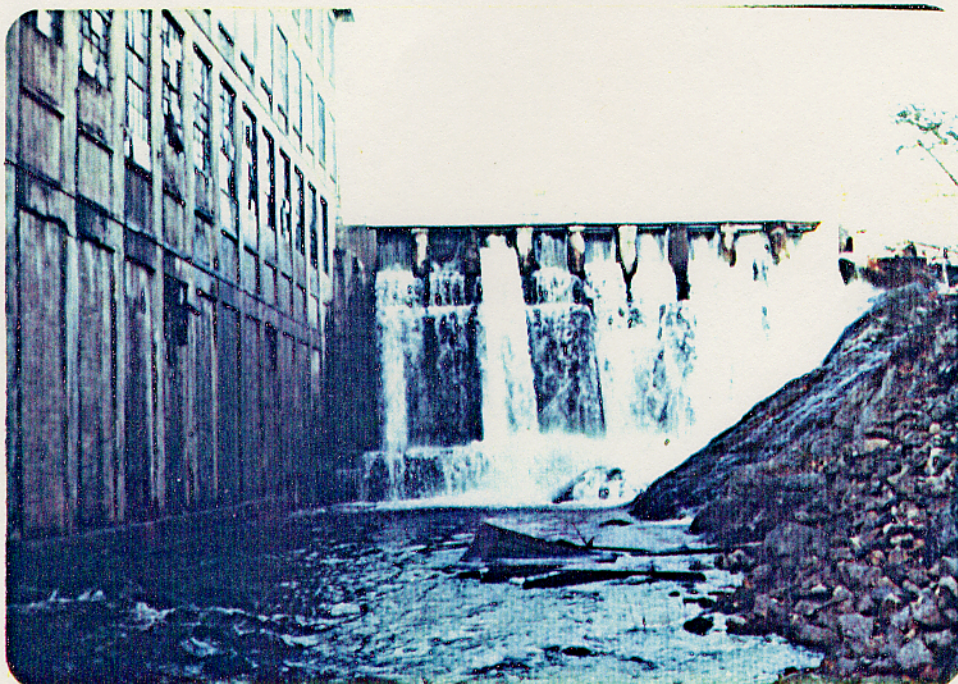
4

- (a) There is no evidence of horizontal or vertical movement of the structure. It appears true to line and grade.
- (b) The stone masonry portion of the dam appears to be in good condition. The masonry appears tight and no unusual seepage or leakage was observed.
- (c) The westerly section of the dam has apparently been rehabilitated since original construction. Four concrete buttresses and a sill have been added to the downstream face and the stop log support piers have been replaced. The buttresses and sill appear to be in good condition. The concrete stop log piers

are badly spalled and reinforcing steel is exposed.

DOWNSTREAM FACE-STOP LOG SPILLWAY

- (1) The concrete stop log piers should be repaired or replaced to prevent further deterioration of the concrete.
- (2) The concrete dike section should be rehabilitated, either by sealing of the upstream face and cleaning and filling of the voids and cracks in the downstream face or replacement.
- (3) Provide around-the-clock surveillance during periods of heavy runoff.
- (4) Develop and implement a formal warning system for use in the event of an emergency.
- (5) Provide for annual inspections of the facility by qualified engineers.

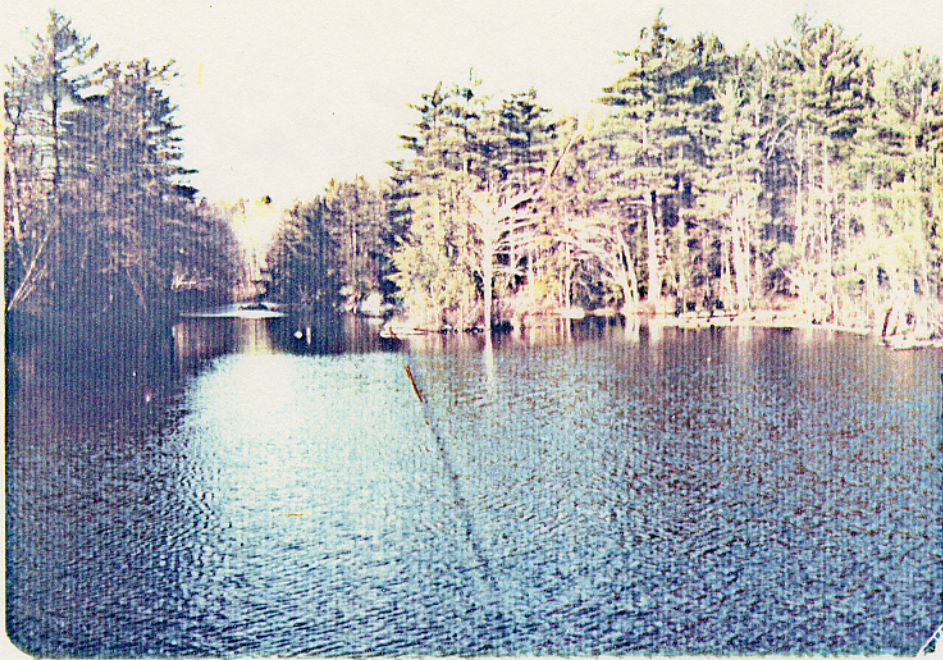
5

UPSTREAM CHANNEL

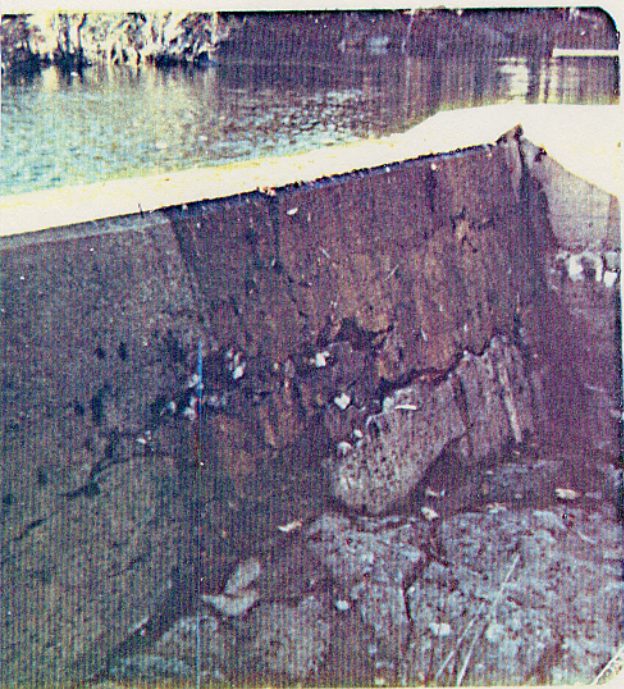
6

- (d) The concrete dike section which extends from the stop log spillway to the gated outlet section is severely deteriorated. This section of the dam ranges in height from 2 to 8 feet and is founded on bedrock. It consists of a vertical downstream face and sloping upstream face. The downstream face is severely deteriorated with deep spalling and cracking through the wall to the upstream face. Heavy leakage is occurring through this section. The westerly portion of the concrete dike is at a slightly lower elevation than the remaining portion. Flow was occurring through and over the dike wall at time of inspection.

DOWNSTREAM FACE-DIKE SECTION

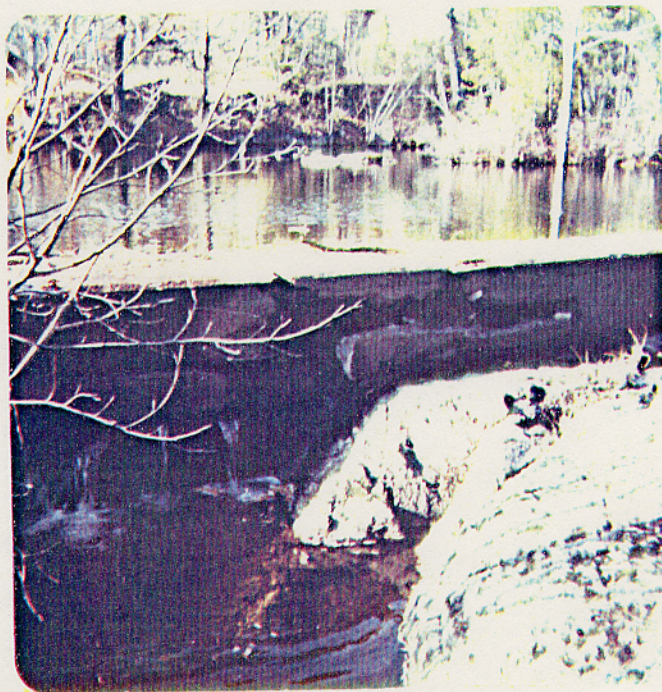
7

DOWNSTREAM FACE-DIKE SECTION
